All-Ceramic Restorations Using VITA YZ CAD/CAM Zirconia Veneered with VM9 Porcelain

Todd C. Snyder, DDS

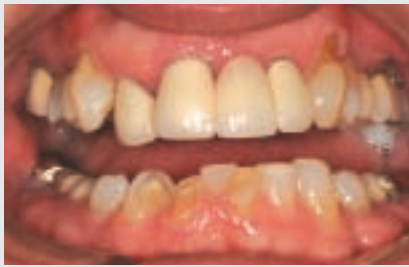
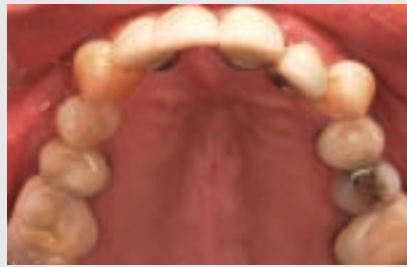
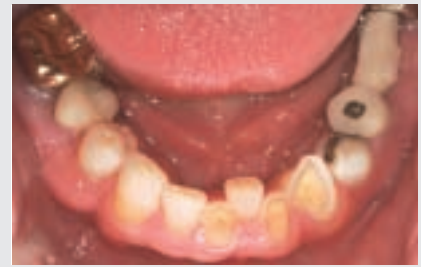
Figures 1 through 3—The preoperative photos of the patient before treatment. Extensive wear, worn down and/or broken restorations and teeth are present.

In this case, a 71-year-old patient presented with a fractured porcelain-fused-to-metal bridge, broken crowns, and a severely worn dentition (Figures 1 through 3). Additional findings included joint noises bilaterally and muscle rigidity in the facial and jaw muscles. The challenge was to address the esthetic rehabilitation of a severely worn dentition as a result of heavy functional wear and broken down restorations.

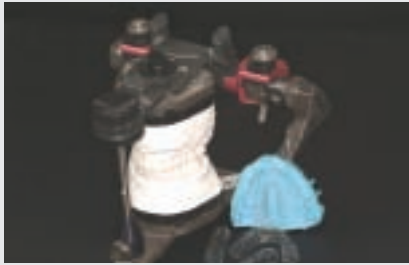
Figure 7—The diagnostic wax-up, over impression, and preparation reduction splint.

diagnostic wax-up was fabricated to achieve the final esthetics and function. A template was also made to create the provisionals (Figure 7).

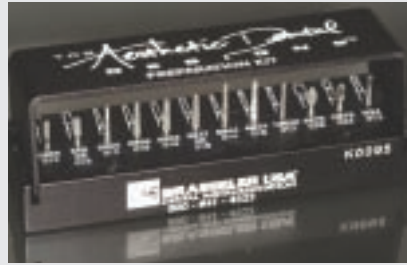
Figure 8—The Aesthetic Dental Designs preparation bur block by Brasseler USA.

All the maxillary teeth were prepared the first day with the Aesthetic Dental Designs bur kit (Brasseler USA) (Figure 8). A final impression was taken using a nonimpregnated #00 cord (Ultradent) and a polyvinyl impression material (Take 1, Kerr Corporation). No astringents were used. Provisionals were created (Fill-In, Kerr Corporation) with the desired final esthetics from the pretreatment diagnostic wax-up. A flat posterior occlusal table was used for the opposing teeth to achieve the same function of the now replaced SRA, until the final restorations were fabricated. This provisional technique allowed for no posterior interferences during parafunctional movements and nocturnal habits.

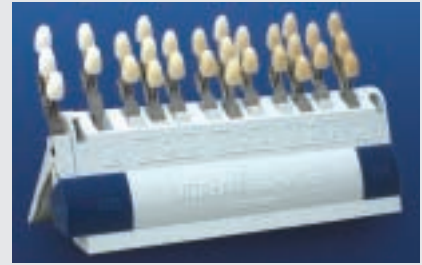
Figure 9—The Vita 3D Master Shade Guide System with the added bleached shade tabs.

Shade selection and related information pertaining to the three dimensions of color (value, chroma, and hue) were chosen using the VITA 3D-Master shade guide (Vident) (Figure 9). The internal anatomy, as well as perikymata, embrication lines, maverick stains, and localized hypocalcifications were communicated to the laboratory technician by means of photographic images and drawings.

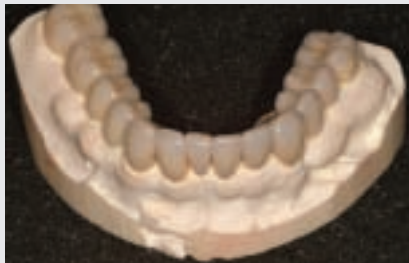
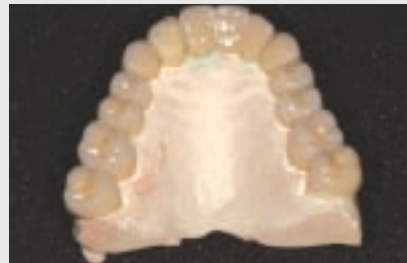
Figures 10 and 11—The final YZ CAD/CAM milled zirconia restorations with VM9 veneering porcelain on solid models.

On the final delivery appointment, the provisionals were removed and the restorations were examined and tried-in to check margins, interproximal contacts, and esthetics (Figures 10 and 11). After verification, the restorations were removed and steam cleaned. The inside of the restorations were then sprayed with the CoJet System (3M ESPE), a surface coating sandblasting material for application of a silicate coating. This coating forms the basis for chemical bonding to a resin-bonding agent. The tooth structure was cleaned with an OptiClean bur (Kerr Corporation) and then the restoration was seated on the tooth using

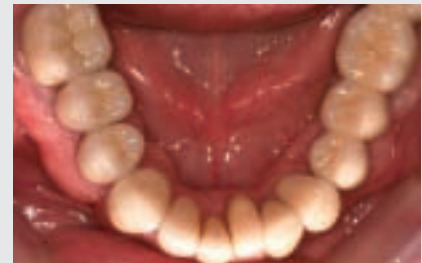
Figures 12 and 13—The final zirconia/VM9 restorations cemented into place with MaxCem self-etching, dual-cure resin (Kerr Corporation).

The fabrication of esthetic, durable, all-ceramic restorations is now made possible through the combination of new technology and new materials. The all-ceramic material used in this case created natural looking ceramic restorations that are esthetically pleasing, durable, and biocompatible (Figure 12 and 13). At the completion of treatment, the patient gained a solid bite and comfortable, everyday function—something he had been missing for a long time. Esthetically, the patient was also pleased with the appearance of his new smile.
